## Asbestos Sample Analysis Report

Due Diligence Testing

**Report Number** A1966.01.ASAM Rev 0  
**Issue Date** 4 April 2023

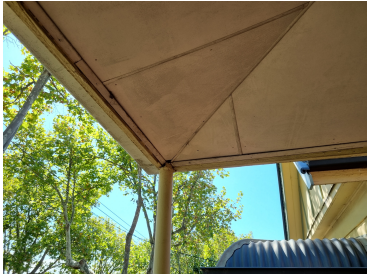
Location & Status	Assessment Details	Photo 1	Photo 2
<b>123 High St, MELBOURNE, VIC 3000</b>			
<b>Under front Verandah</b> Cement Sheeting Status: <b>Positive</b> i.e. the sample <b>contains</b> asbestos	<b>Your Reference Sample 1</b> <b>Lab Sample Number</b> GL008587 <b>Outcome</b> Chrysotile Asbestos Detected

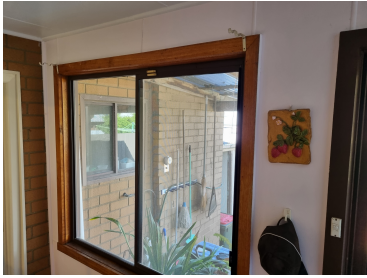
<b>Fully Enclosed Back Verandah (sun-room)</b> Cement sheeting (on wall & ceiling) Status: <b>Positive</b> i.e. the sample <b>contains</b> asbestos	<b>Your Reference Sample 2</b> <b>Lab Sample Number</b> GL008588 <b>Outcome</b> Chrysotile Asbestos Detected

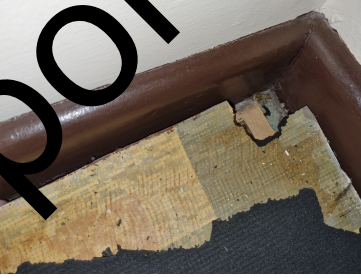
Location & Status	Assessment Details	Photo 1	Photo 2
<b>123 High St, MELBOURNE, VIC 3000 (continued... )</b>			
<p><b>Under Carpet in lounge/hall way</b></p> <p>Old Vinyl Flooring</p> <p>Status: <b>Negative</b></p> <p><b>i.e. the sample <u>does not</u> contain asbestos</b></p>	<p><b>Your Reference</b> Sample 3</p> <p><b>Lab Sample Number</b> GL008589</p> <p><b>Outcome</b> <i>No Asbestos Detected</i></p>

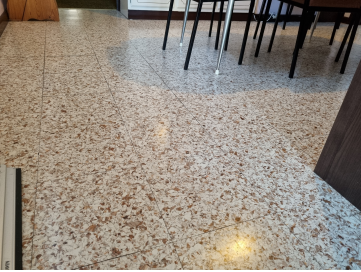
<p><b>Kitchen / Dining Area</b></p> <p>Vinyl Tiles</p> <p>Status: <b>Negative</b></p> <p><b>i.e. the sample <u>does not</u> contain asbestos</b></p>	<p><b>Your Reference</b> Sample 4</p> <p><b>Lab Sample Number</b> GL008590</p> <p><b>Outcome</b> <i>No Asbestos Detected</i></p>
